### HOW ACCURATE ARE 3D-ECHO MEASUREMENTS? COMPARISON OF IN-VIVO MEASUREMENT OF PROSTHETIC VALVE SEWING RING DIAMETER TO KNOWN PROSTHESIS SIZE

ACC Moderated Poster Contributions  
McCormick Place South, Hall A  
Saturday, March 24, 2012, 9:30 a.m.-10:30 a.m.

Session Title: Imaging: Echo 3D  
Abstract Category: 22. Imaging: Echo  
Presentation Number: 1091-14

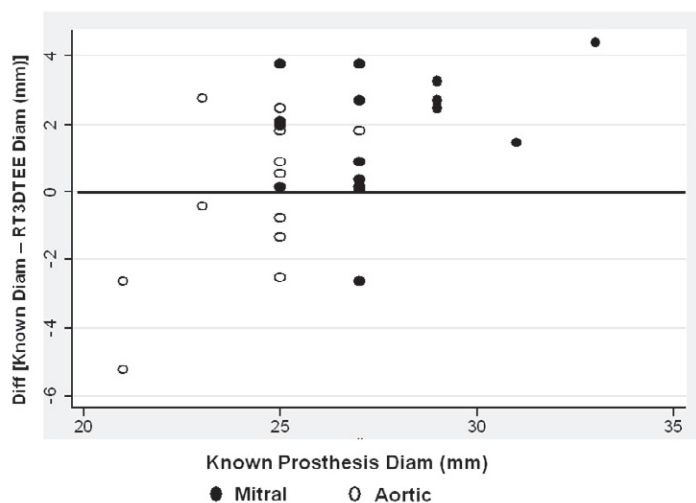
**Results:** Patients were  $64 \pm 14$  years and 52% female. There were 16 with MV and 14 with AV prostheses. RT3DTEE under-estimated MV prosthesis diameter by  $1.8 \pm 1.8$  mm ( $p=0.002$ ), whereas AV prosthesis diameters were not biased toward over or under-measurement ( $-0.2 \pm 2.3$  mm,  $p=0.8$ ), Figure. 2DTEE measurements were not biased toward over or under-measurement for both MV ( $-0.7 \pm 2.1$  mm,  $p=0.2$ ) and AV ( $-0.2 \pm 1.8$  mm,  $p=0.7$ ).
